# National Transportation Safety Board

## Group Chairman's Factual Report

Fire and Explosions Group

DCA19MM047

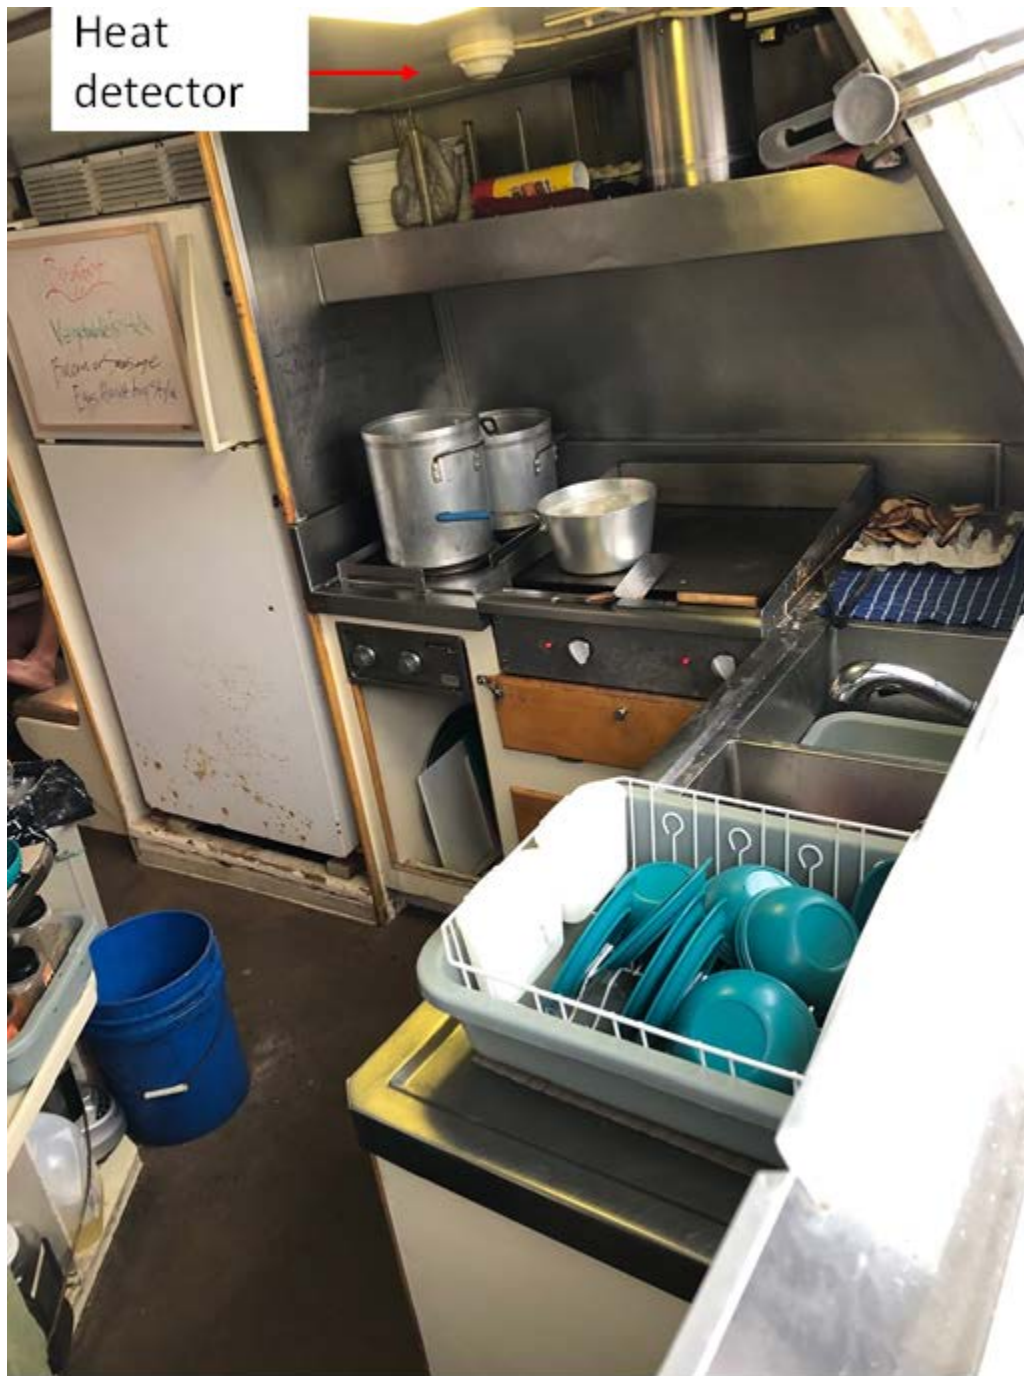
The *Conception* had a carbon dioxide fixed fire-suppression system installed in the engine room (required from the New-T regulations). The galley exhaust hood also would have been required to have a built-in, fixed fire-suppression system based on the updated regulations (section 181.425). An exemption for this was approved July 6, 2000 by the Coast Guard Officer in Charge, Marine Inspection (OCMI). This exemption allowed for alternative compliance by the use of a heat detector alarm in the vicinity of the exhaust hood, a

Figure 7. Photo of the galley of the Conception taken from the forward centerline window.  
(Source: J. Palmer)

maintenance program to ensure the existing galley ventilation system was kept free of grease and the addition of an additional B-II portable fire extinguisher for use in the galley (figure 7).

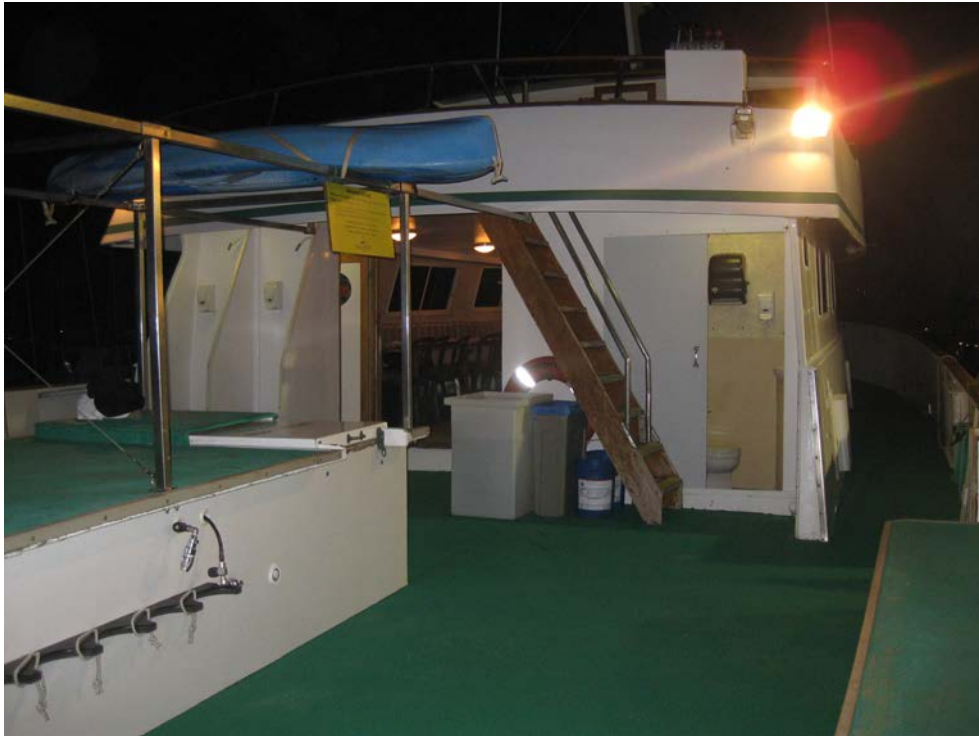
On the exterior of the aft portion of the salon compartment in the vicinity of the stairway to the upper deck there was a large polyethylene trashcan (Figure 9). Undetermined, ignition sources in this area, such as improperly discarded smoking materials cannot be discounted. Therefore, the potential ignition sources in the vicinity of the aft portion of the salon include:

Figure 9. Toilets and stairway to the upper deck of the *Conception*. Note the storage of a polyethylene trash can, food waste containers, and a rinsing container under the stairway in front of the life ring. (Source: M. Ryan)

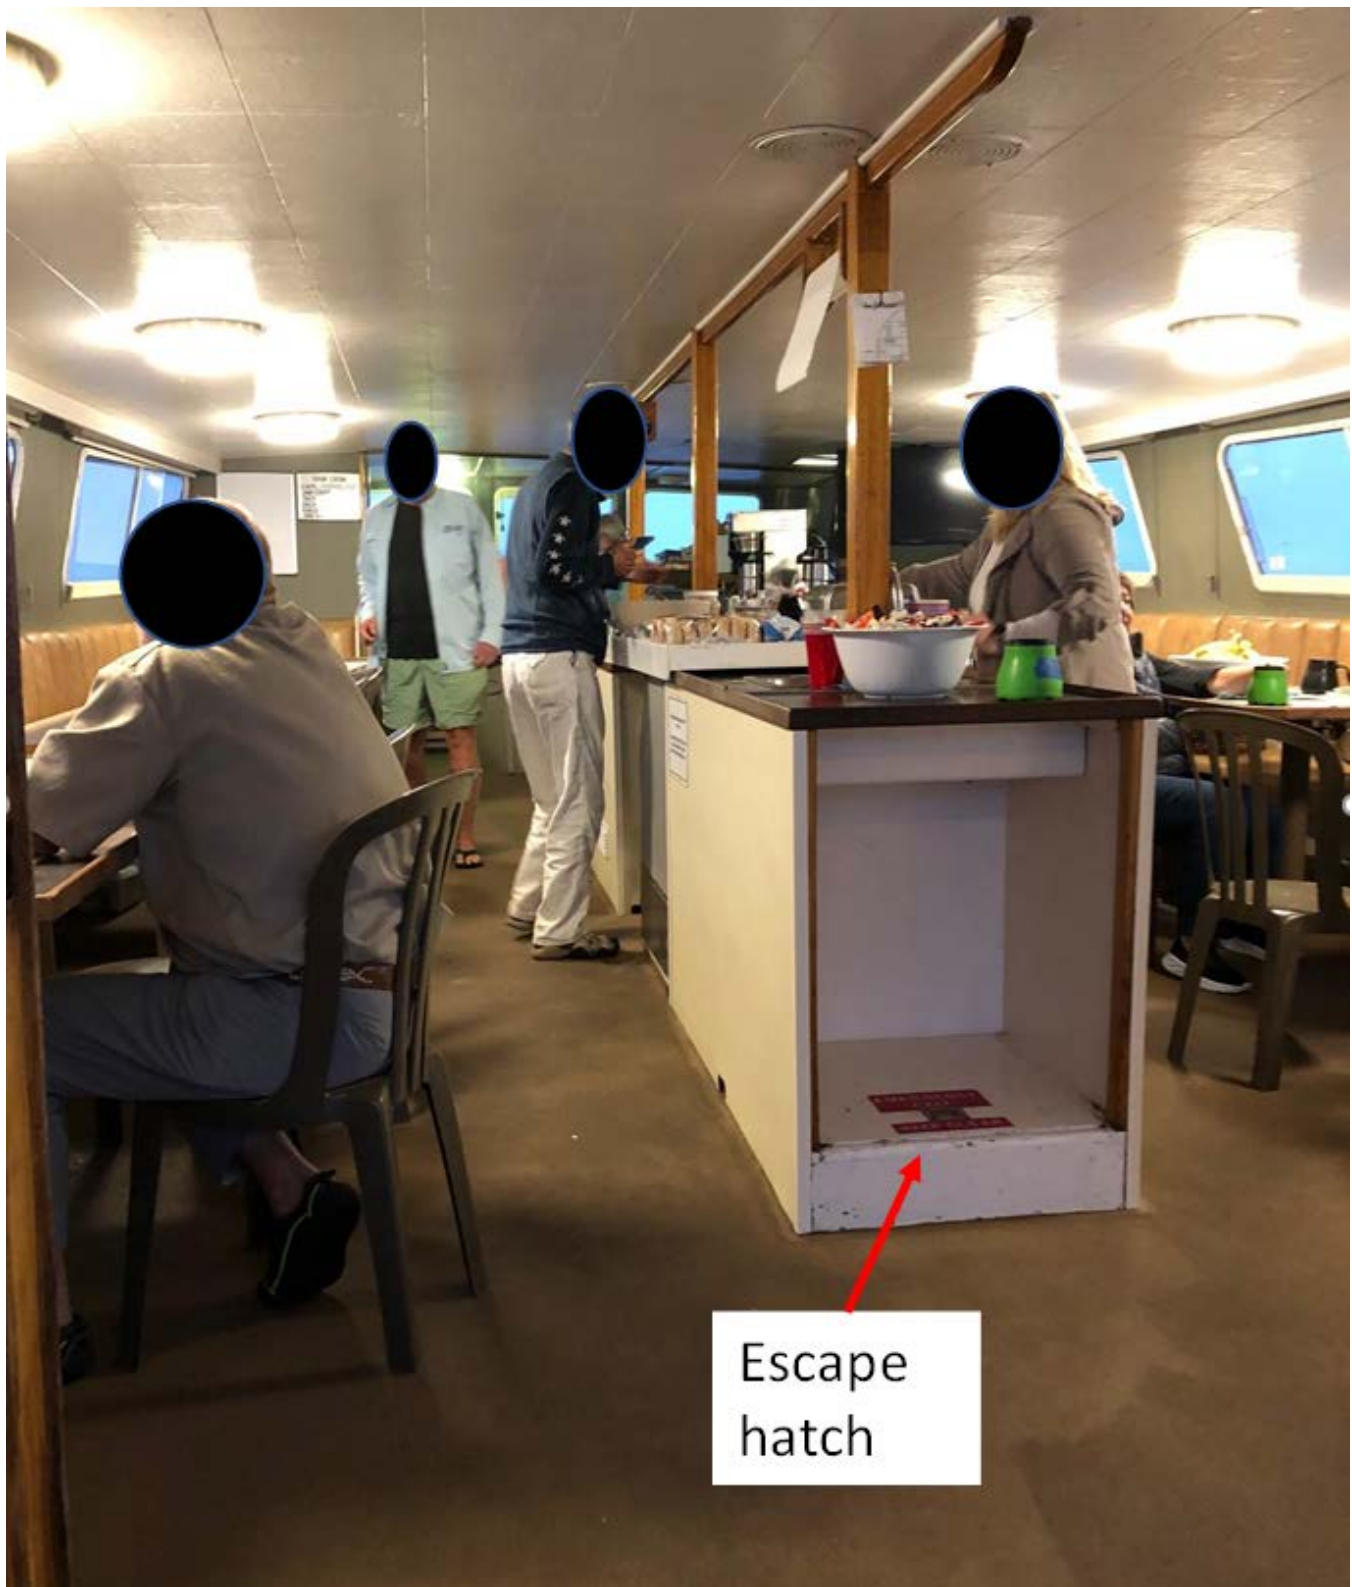
of the bunk spaces were covered with carpeting. The ceiling was lined with acoustic tile. There was one modular smoke detector on the ceiling in each of the aiseways (for a total of two smoke detectors in the bunkroom). The bunkroom also had an emergency exit hatch located at the rear of the bunkroom above one of the passenger bunks. The emergency exit hatch led to the aft portion of the salon (figure 14).

The passenger bunkroom also complied with the applicable egress regulations requiring two independent means of emergency exit: (1) the main staircase in the forward part of the bunkroom compartment and (2) the escape hatch above a passenger bunk at the aft end of the bunkroom compartment. Both exit pathways lead the passengers into the salon and galley compartment. This configuration was approved by the Coast Guard as per the means of escape regulations previously referenced. This allowable configuration played a role in the accident.

Figure 14. Location of emergency escape hatch from the bunkroom in the aft salon of the *Conception*. (Source: J. Palmer)

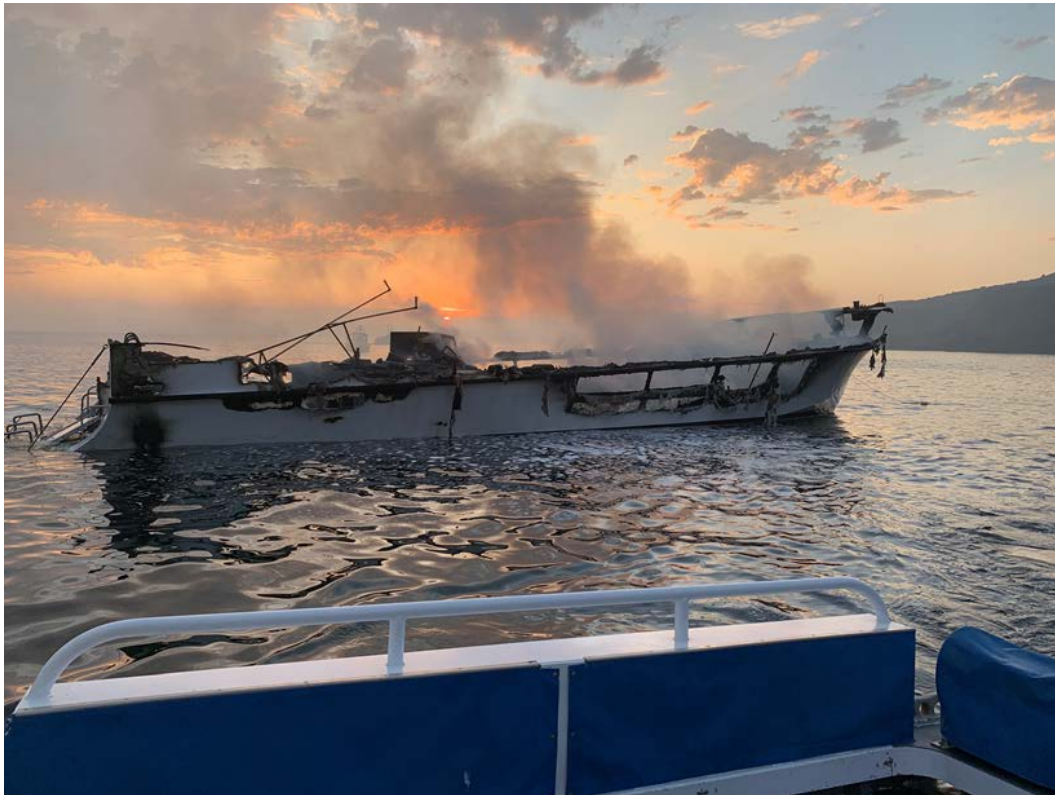
The *Conception* sank at 0658, about 3 hours and 44 minutes after the fire was initially reported. A photo of the *Conception* was taken by one of the responding fire boats after the fire had been extinguished and before it sank (figure 15). The wreckage was recovered over the next couple weeks following the accident and was transported to and stored at a Naval base in Ventura County, Port Hueneme, Oxnard, California, where it was examined by the National Transportation Safety Board (NTSB) on September 26–27, 2019. Debris and personal effects still contained inside the wreckage had been removed by the Federal Bureau of Investigation (FBI) and the Bureau of Alcohol, Tobacco, Firearms, and Explosives (ATF) prior to NTSB investigators being permitted to examine the wreckage. The wreckage and debris recovered from the seafloor or surface was laid out by the ATF and FBI in a secure parking lot into three sections consisting of the main hull with the below deck spaces, the main deck, and the upper deck (figure 16). There was also an area with bags full of items that had been floating in the water and from the seabed that were collected. The ATF and FBI had placed the recovered items and portions of structure that could be identified in their corresponding places for each of the three sections of the wreckage representing the three decks. For the main deck and upper deck portions, an outline had been made on tarpaulin underlays, and the items/structure were placed within the outlines in the areas where they belonged. As seen in figure 16, very little material remained from the upper deck and the main deck.

Figure 15. Small passenger vessel *Conception* at sunrise prior to sinking. (Source: Ventura County Fire Department)

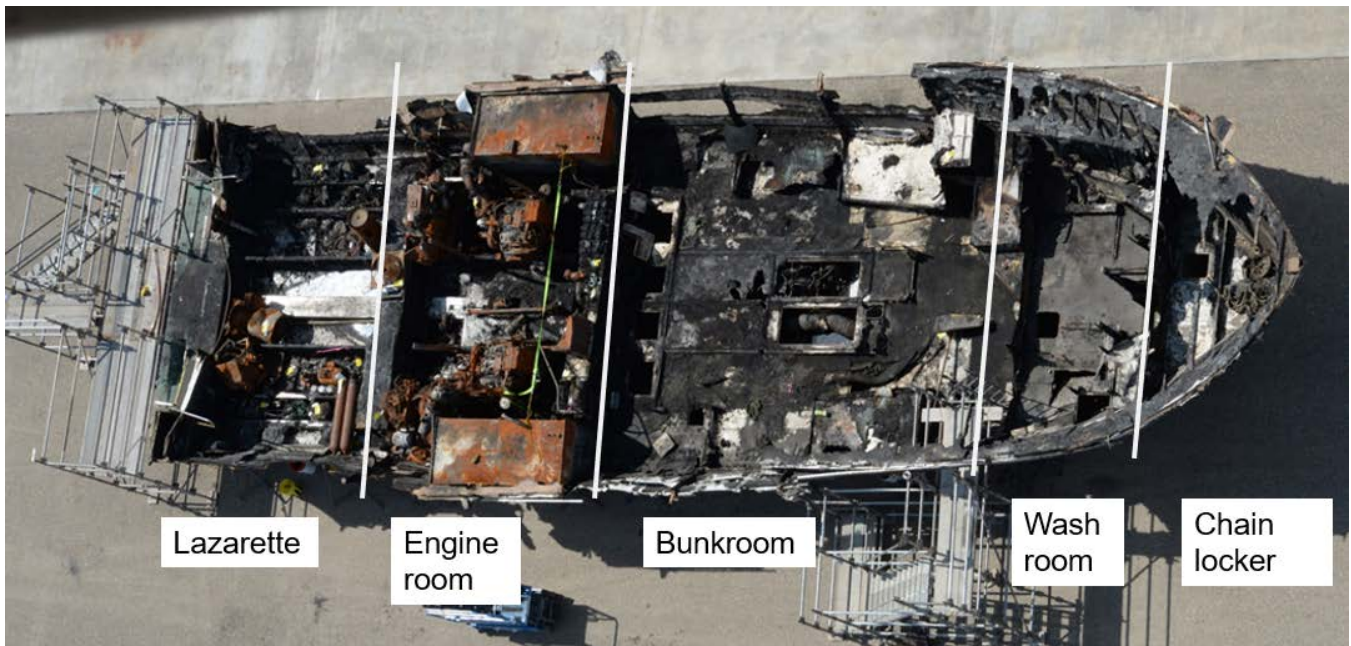
The hull of the *Conception*, where the below-deck compartments had been located, represented the bulk of the remaining structure. There was no longer separation of the below-deck compartments between the anchor room, shower room, bunkroom, engine room, and lazarette going from forward to aft. The entire interior of the below-deck space was charred, with some exceptions in areas that likely became covered by collapsing structure and thus were protected from thermal exposure. Overall, the interior of the below-deck compartments had burned all the way down to the floor in the bunkroom and shower room and consumed the floor, exposing the longitudinal frames in both the engine room and lazarette (figure 17).

Figure 17. Below-deck areas of the *Conception*. The solid, white lines mark the approximate boundaries of each compartment. (Source: FBI ERT)

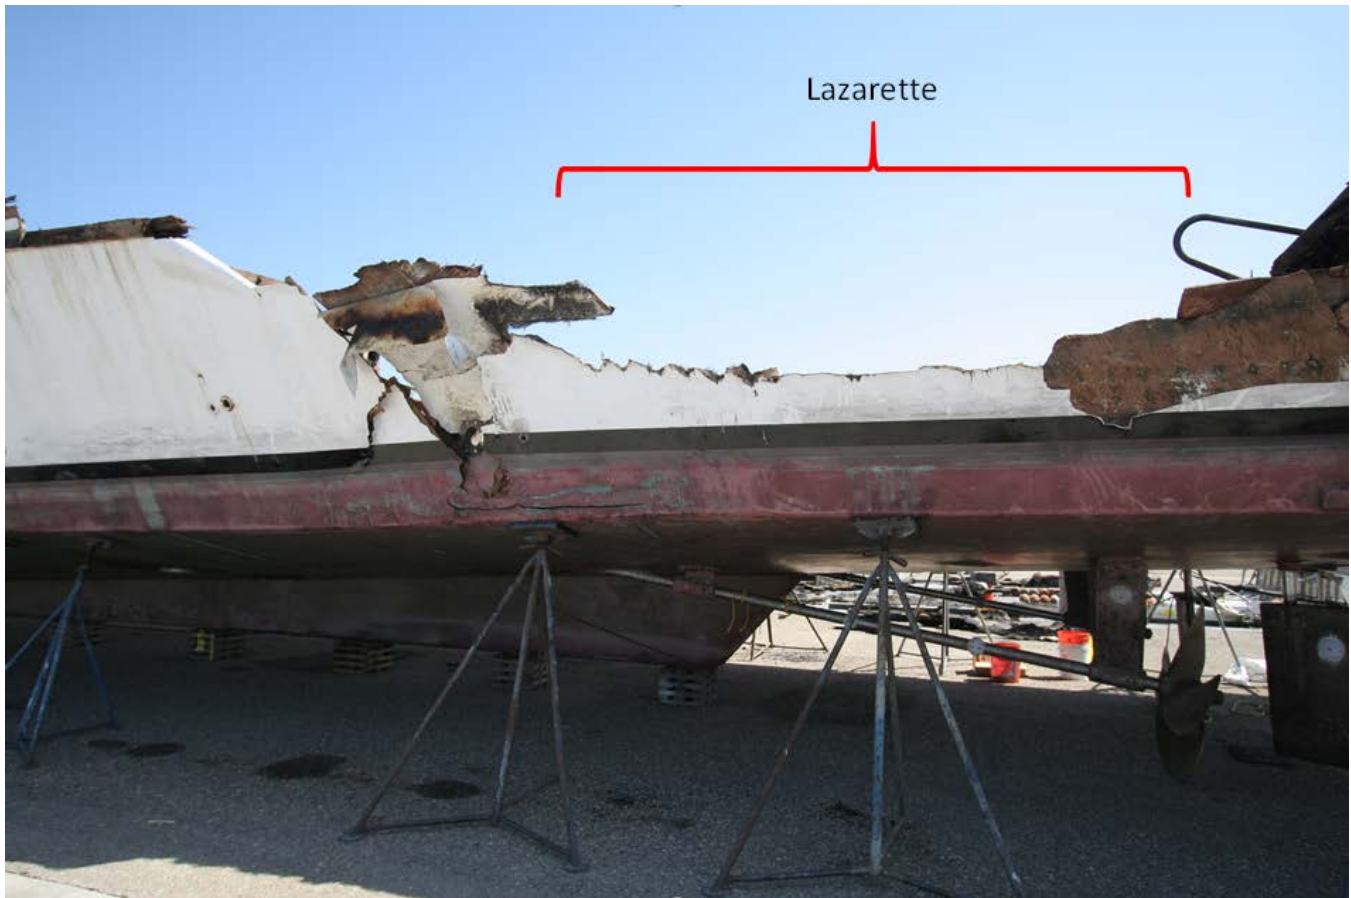
Port-side portions of the hull exterior had burned down to a few inches from the water line. The areas with the fire damage closest to the waterline corresponded with the locations of the lazarette compartment (figure 18) and the passenger bunkroom (figures 19 and 20).

Figure 18. Port side aft of the *Conception* hull. (Source: FBI ERT)

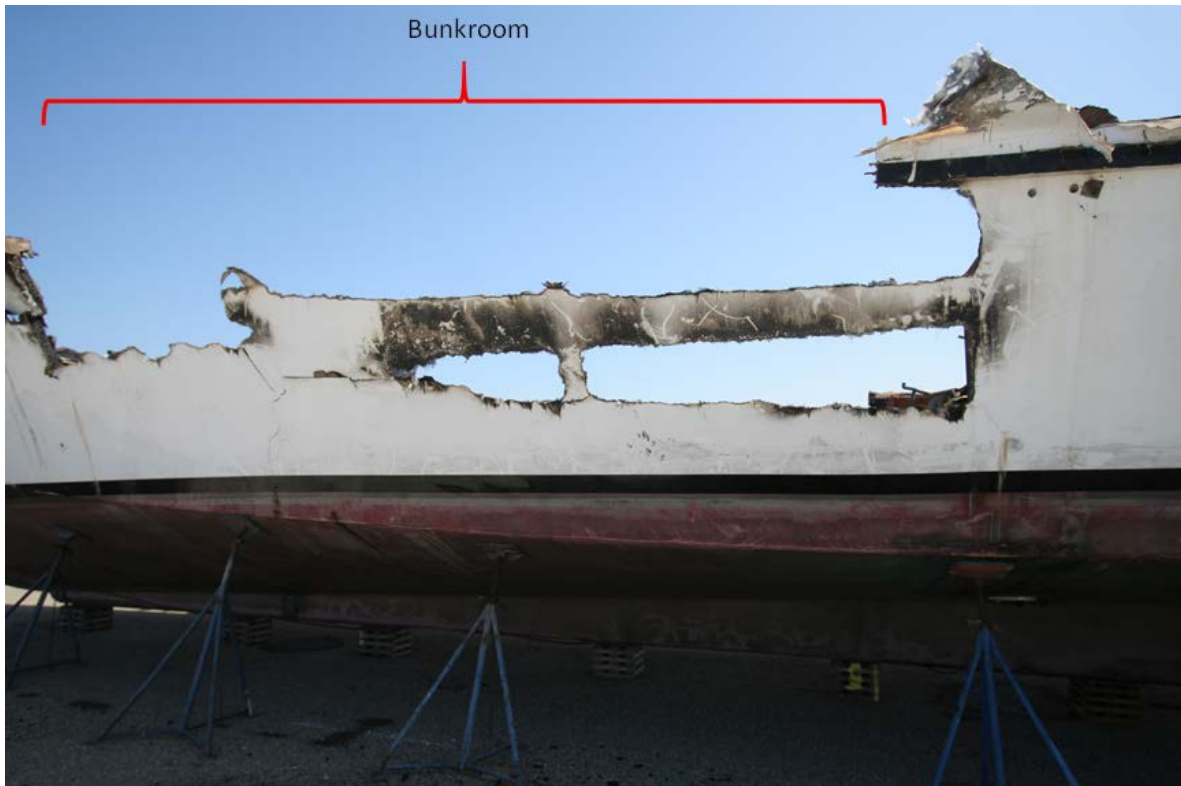
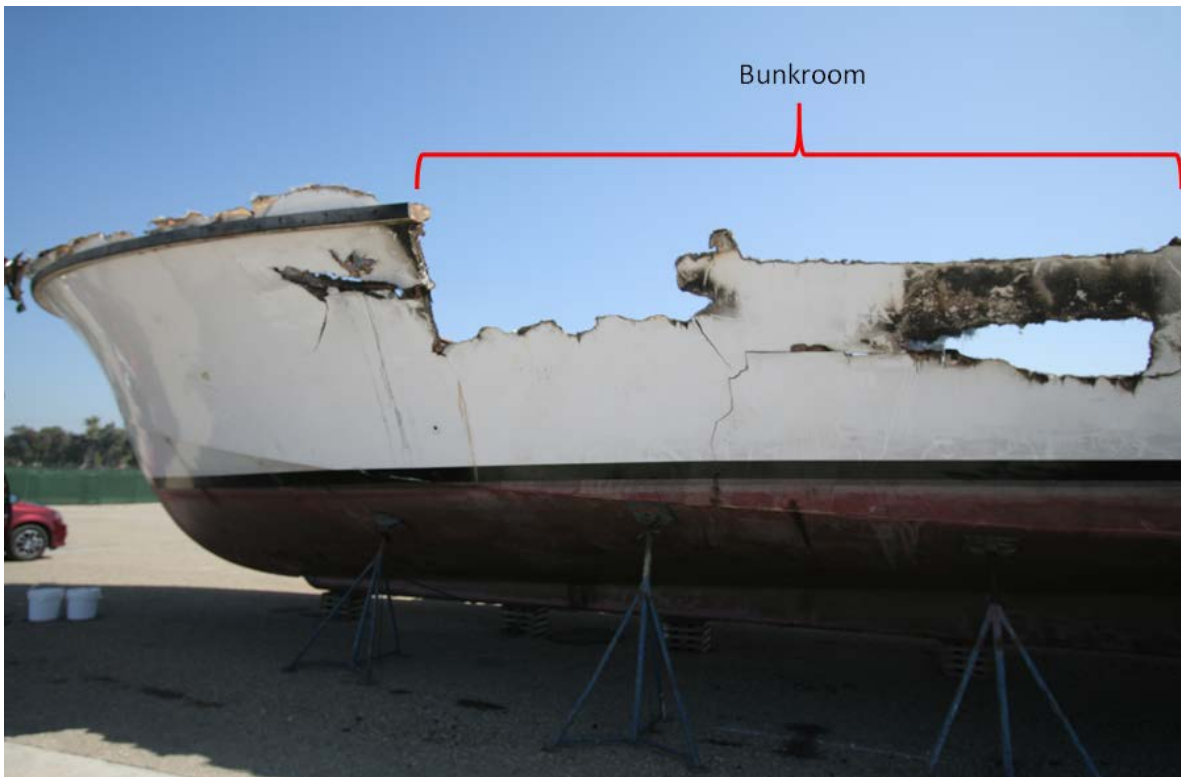
Figure 19. Port-side mid-section of the *Conception* hull. (Source: FBI ERT)

Figure 20. Port side of the *Conception* hull. (Source: FBI ERT)

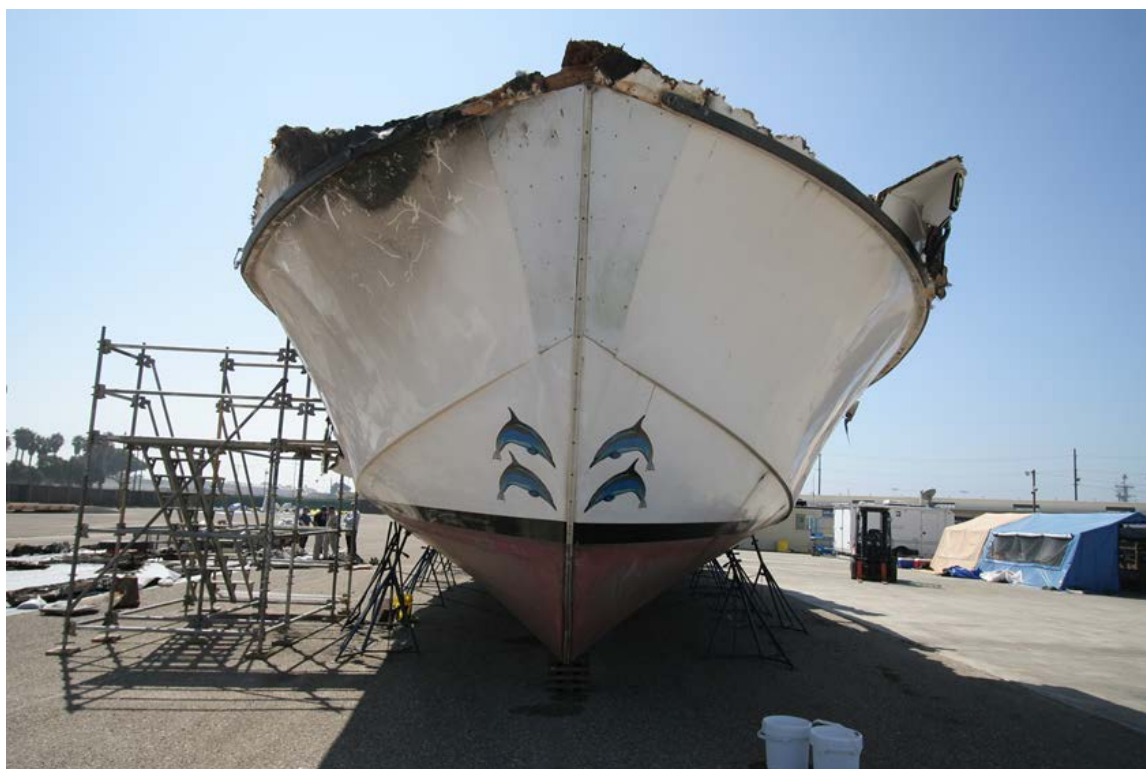
On the bow portion of the hull exterior, the fire burned down to the level of the main deck rub rails (figure 21).

Figure 21. Bow of the *Conception* hull. (Source: FBI ERT)

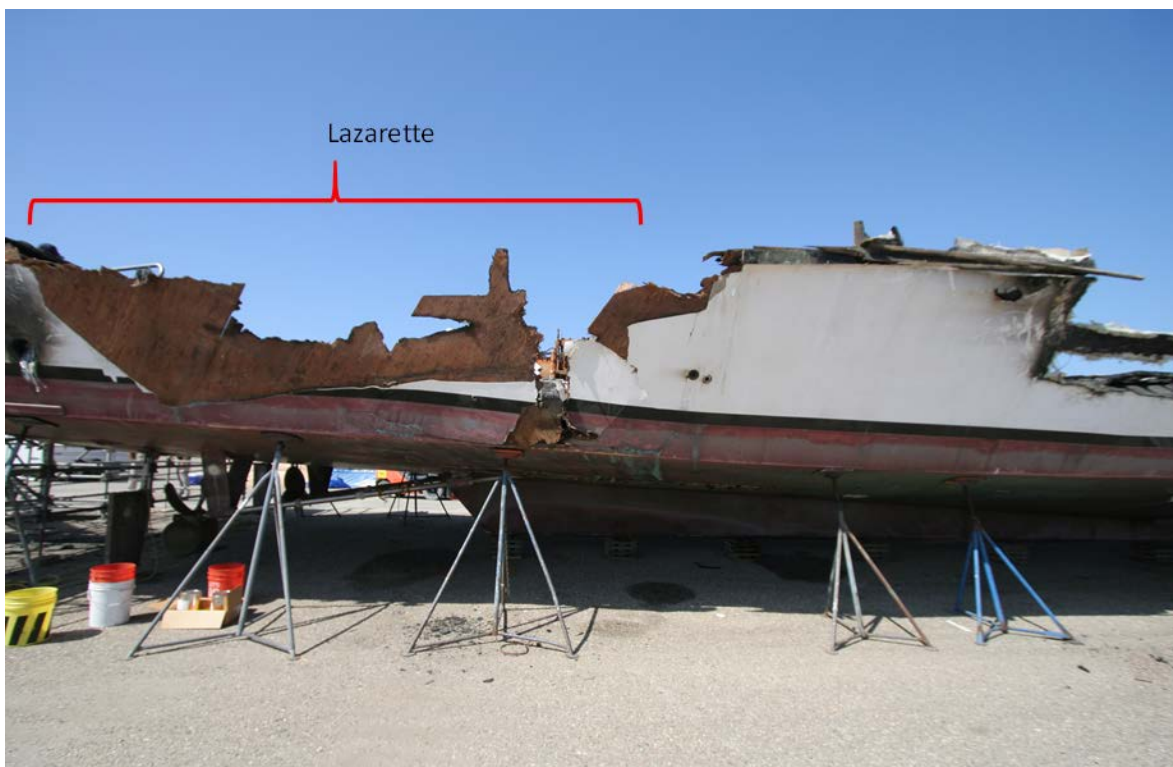
On the starboard side of the hull exterior, as on the port side, the areas with the closest to the waterline fire damage corresponded to the lazarette (figure 22) and passenger bunkroom areas (figure 23). Overall, the area of lowest burn-through of the hull on the starboard side of the passenger bunkroom was larger than the area of lowest burn-through on the port side.

Figure 22. Starboard aft side of the *Conception* hull. (Source: FBI ERT)

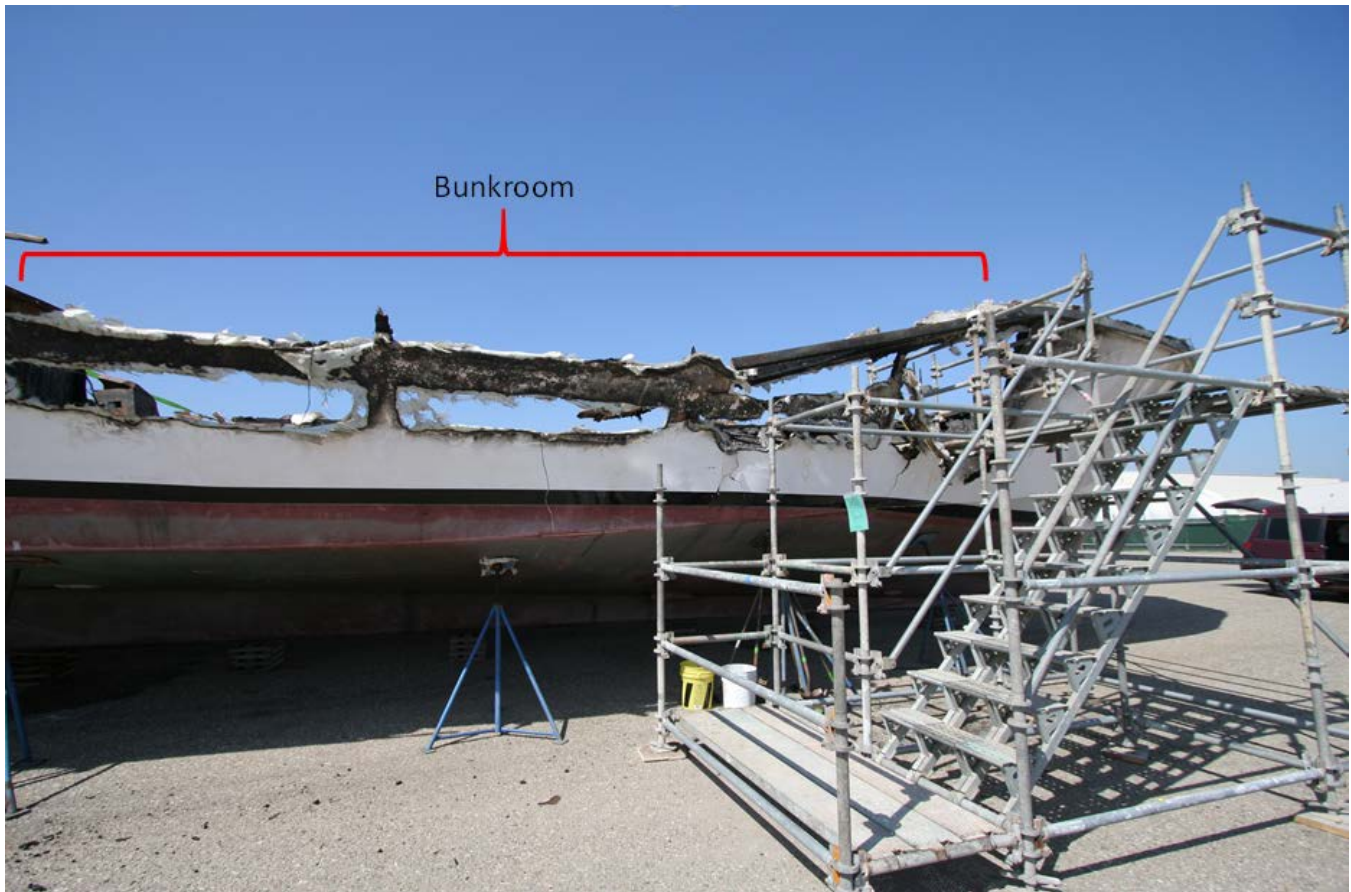
Figure 23. Starboard mid- and forward-section of the *Conception* hull. (Source: FBI ERT)

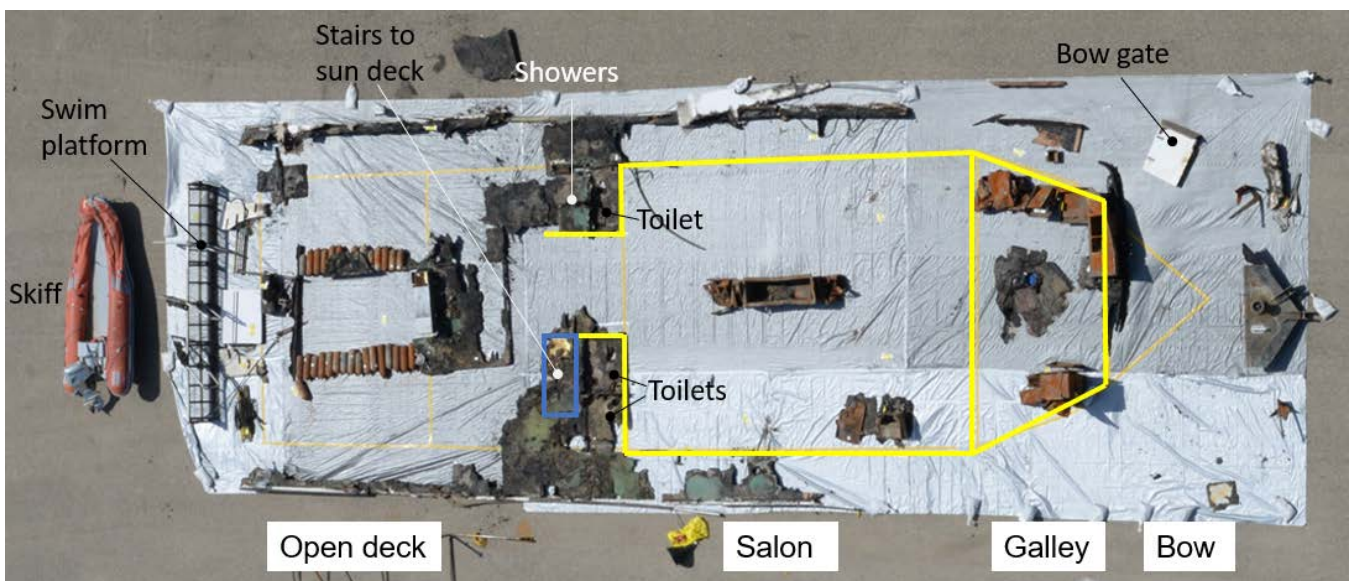
The structure and items recovered belonging to the main deck of the vessel consisted mostly of a few pieces of partially charred deck material and the noncombustible remains of the galley and salon equipment (figure 24). The decking material that remained belonged to the three toilets on the main deck and small portions of the port and starboard walkways that were adjacent to them.

Figure 24. Wreckage belonging to the main deck of the *Conception*. Solid, yellow lines indicate the enclosed spaces on the deck. The blue box marks the location of the stairway to the sun deck. (Source: FBI ERT)

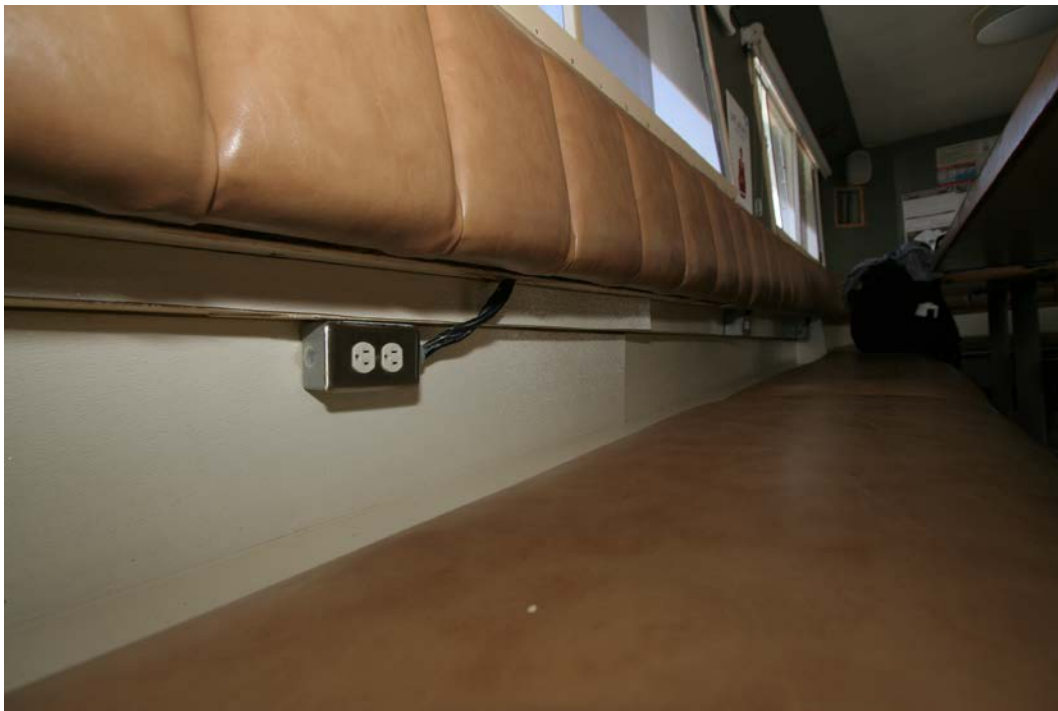
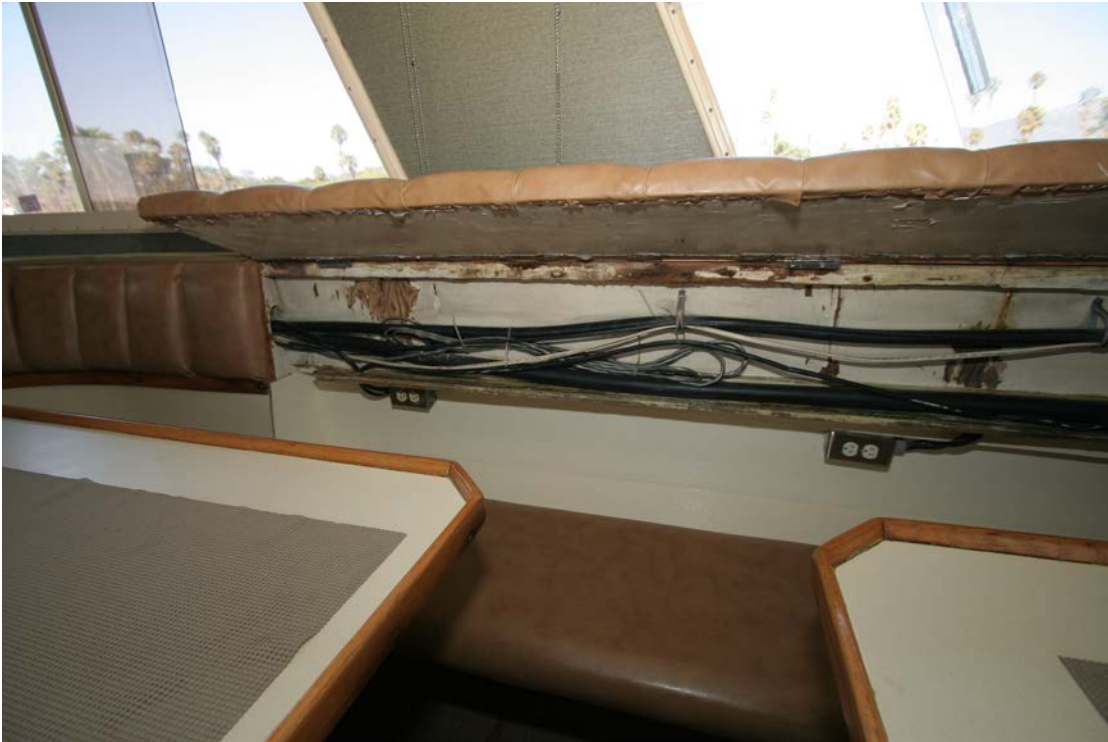
Examination of the salon for potential ignition sources only revealed electrical systems. There were cable runs located behind the seatback of the bench-type seating and receptacle drops just under the seatbacks (figures 32, 33). The electrical cable runs were not enclosed in protective conduit, were often not supported, and did not have the appearance of a professional installation. In the bunkroom, more signs of non-professional electrical installations were also observed, including a lighting fixture in the bunkroom (figure 34). Discussion with the owner revealed that during trips, the aftmost tables were often used as charging stations for the customer's electronic devices. These devices would typically consist of rechargeable flashlights, cameras, strobe lights, laptops, and cell phones. This practice of using the aftmost tables as designated charging stations was also employed on the *Conception* according to crew interviews. Photos submitted to the NTSB by previous passengers depict the practice of using the aftmost tables as charging stations (figure 35).

Figure 32. Electrical outlet drop below seatback on the *Vision*.

Figure 33. Cable run behind the starboard-side bulkhead seating of the *Vision*.

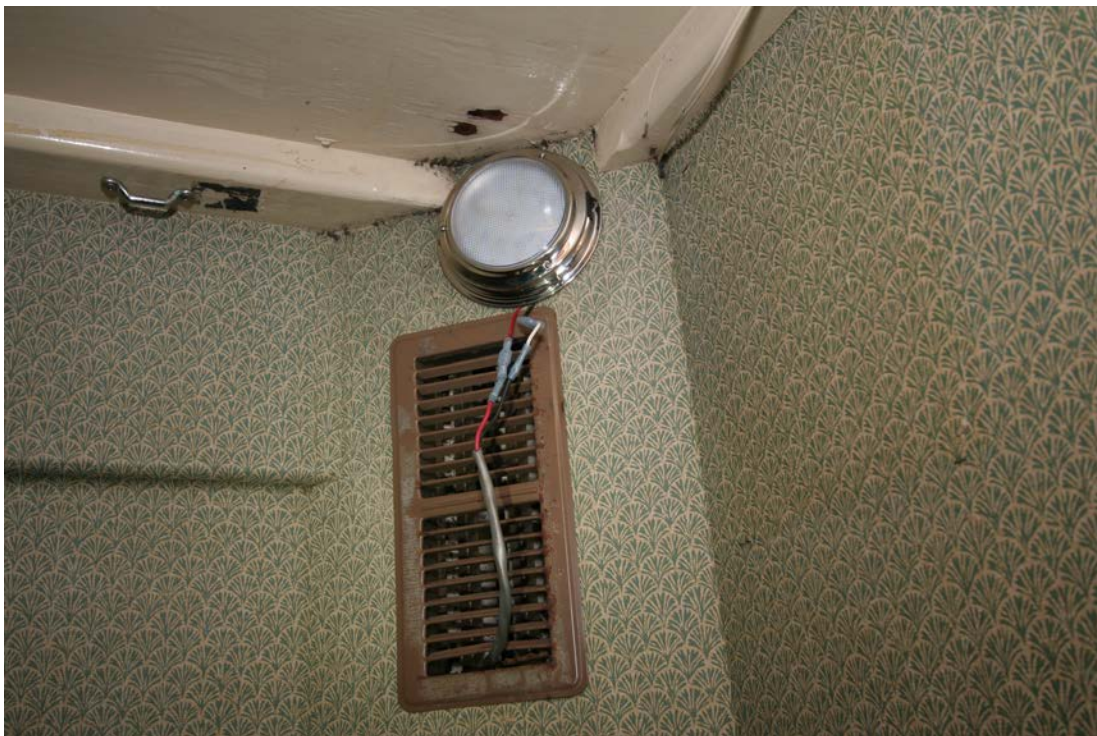
Figure 34. Power cable for lighting routed through ventilation grille in the *Vision* bunkroom.

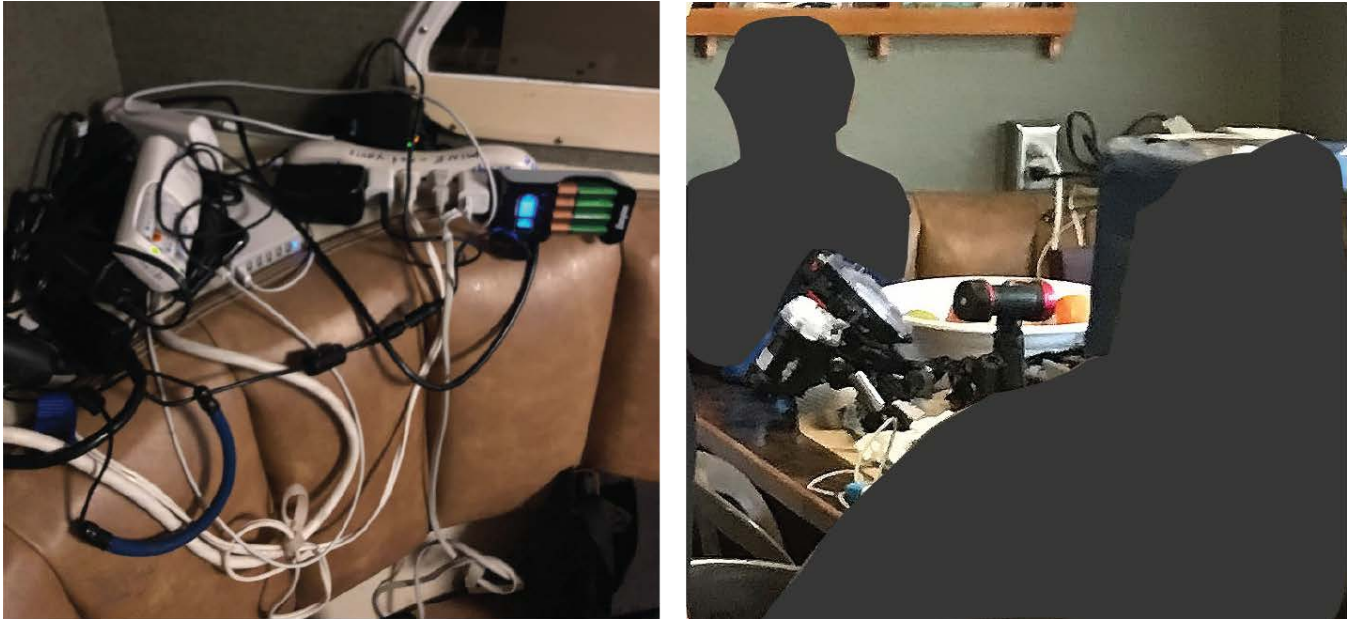
Based on the crew interviews and statements from previous passengers it is believed that there were numerous electronic devices being charged overnight in the aft portion of the salon. Batteries (in particular, lithium-ion batteries) have a known and documented history of initiating accidental fires. In the past, the Consumer Product Safety Commission has issued numerous product safety recalls due to fires caused by electronic devices with defective batteries and chargers. The NTSB has investigated accidents in which battery failures led to fires. The Federal Aviation Administration has strict regulations on the carriage of lithium-ion batteries aboard passenger aircraft based on a long history of incidents involving fires. It is therefore reasonable to include lithium-ion battery failure as a possible ignition source in this fire scenario.

Figure 35. Left: August 31, 2019 photo of devices plugged in at the port side aft corner of the salon on the *Conception* (source: FBI). Right: September 1, 2019 photo showing various devices charging on the table and electrical cables running from the outlet on the port side aft corner of the salon (source: FBI).
