# National Transportation Safety Board

## Group Chairman's Factual Report

### Survival Factors Group

DCA19MM047

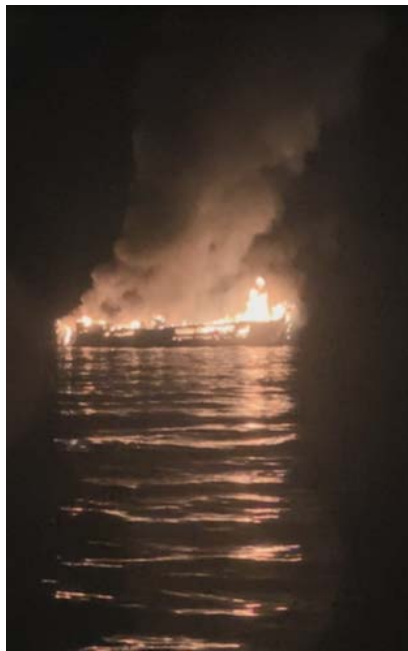
**Figure 5: *Conception* as seen on arrival by *Boat 15*. (Source: VCFD)**

7 CG 45643 was the first SRU to arrive on scene at 0427 and started searching for survivors.  
8 They found the *Conception* completely engulfed in flames. CG 45739, with Engine 53 embarked,  
9 arrived on scene immediately after and assumed the role of On Scene Coordinator (OSC).<sup>16</sup>  
10 CG 45739 transferred two firefighters (a paramedic and an EMT) to the *Grape Escape* to assess  
11 the injured *Conception* crewmembers and then began searching the area for any other survivors.

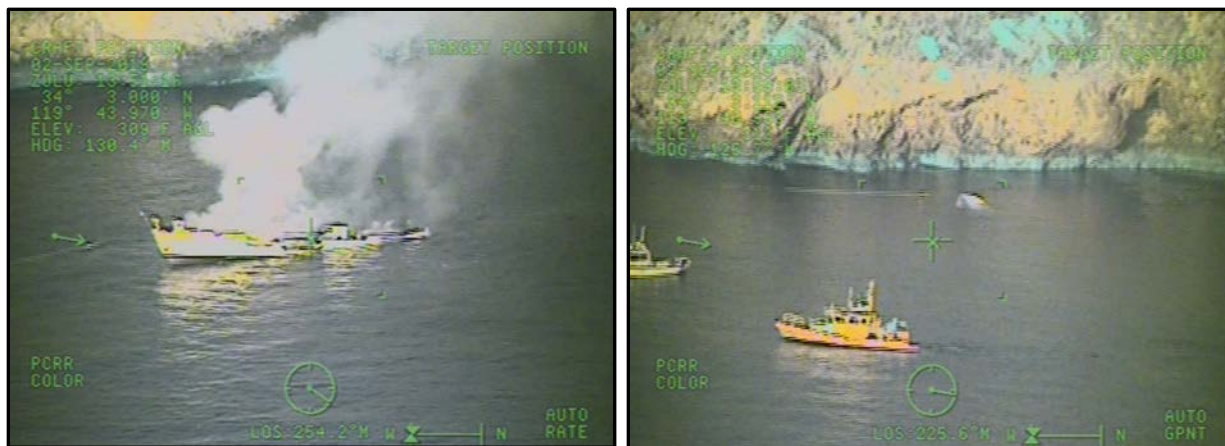
1           *Boat 15*, with Engine Company 54 embarked, arrived on scene, followed by *Boat 3*, and  
2 commenced fire suppression efforts, first with fire monitors and then with handlines. The  
3 *Retriever II* arrived on scene at 0502 and shortly after began towing the burning wreck away from  
4 the shallow water with a grappling hook to a location where the fire boats could better reach it.  
5 The fire was first reported extinguished at 0508 but re-flashed several times in the area of the fuel  
6 tanks and on the bow. Burned out through-hull penetrations eventually submerged, where the main  
7 engine exhausts had been, and the vessel sank stern first in position 34° 02.9' N 119° 44.3' W at  
8 0654, approximately 20 yards from shore, in 61 feet of water. First responders were not able to  
9 safely board the vessel before it sank. Underwater recovery divers later found the wreckage, lying

11  
12 **Figure 6: *Conception* as seen from CG 6014 at 0651 (left) and at 0659 after sinking (right). (Source:**  
13 **Coast Guard)**

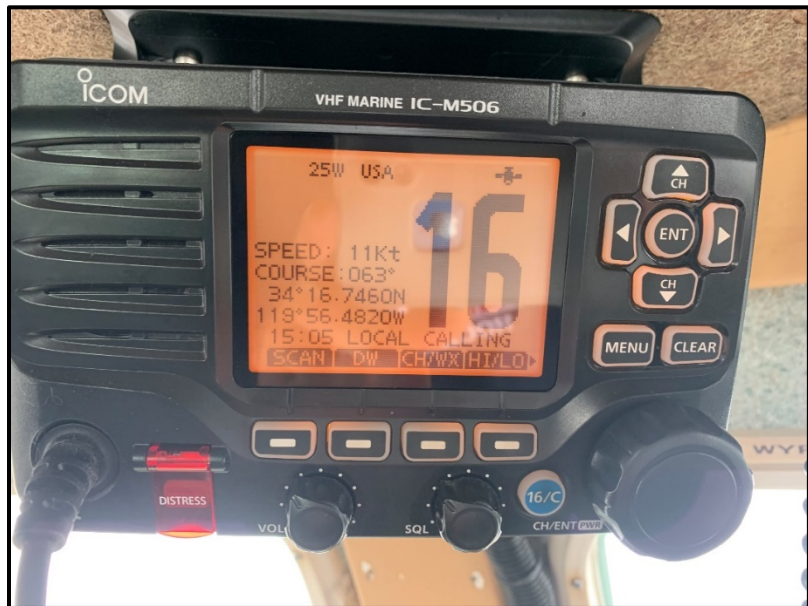
**Figure 9: Conception's VHF radio located overhead in the wheelhouse. The VHF-DSC distress button in the lower left is color-coded red. (Source: B. Priddin)**

communications by voice, by pushing and holding the red distress button on the front panel of the radio for three seconds, a VHF-DSC call would communicate the nature of the distress (default to undesignated distress, if the user did not input this) and the latest position of the vessel, and would have continued to transmit distress messages every 3.5 to 4.5 seconds until the call was acknowledged. Due to the nature of the criminal investigation, investigators were not permitted to interview the captain to determine if he initiated a VHF-DSC distress call. The Coast Guard, however, did not receive a VHF-DSC distress call from the *Conception*, nor did any other vessels contacted by investigators.

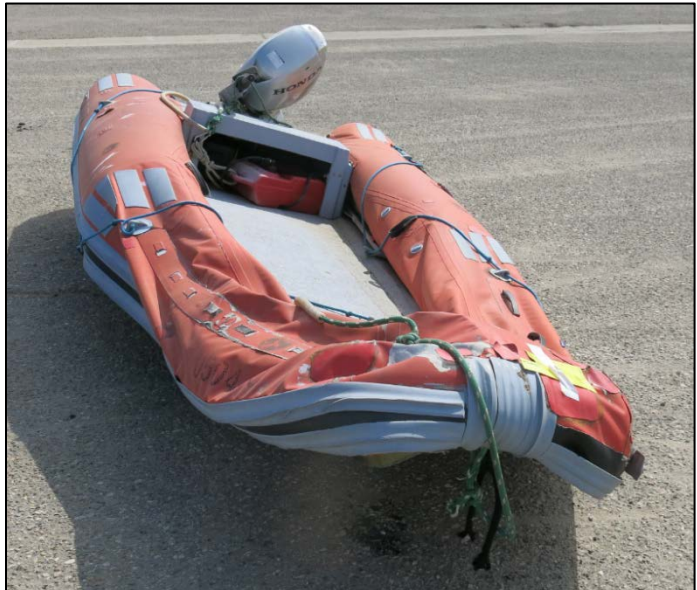
The deckhand used a knife, kept near the stern, to cut the line securing the bow of the skiff. While the captain boarded the skiff and the second captain worked to start the outboard motor, the deckhand returned to the engine room hatch opening in an attempt to start the fire pump. He found the engine room full of white/grey smoke, and realizing the fire stations were inaccessible, he elected not to enter the cramped engine room. The first galleyhand had broken his left tibia in the jump from the upper to the main deck. The second galleyhand suspected he had twisted an ankle in the jump. Since the two galleyhands (without lifejackets), one of which had a serious leg injury, had yet to be rescued from the water, the deckhand joined the others in the skiff as ordered by the captain. The stern line was still attached as the three crewmembers attempted to pull away from the *Conception*, requiring the deckhand to re-board the burning vessel to retrieve the knife. He cut the stern line, which then got wrapped in the outboard motor propeller. The crew paddled the skiff away from the vessel as the deckhand cleared the line, twice, from the propeller.

**Figure 10: Postaccident photo of the skiff from the *Conception*. Note the cut line at the bow**

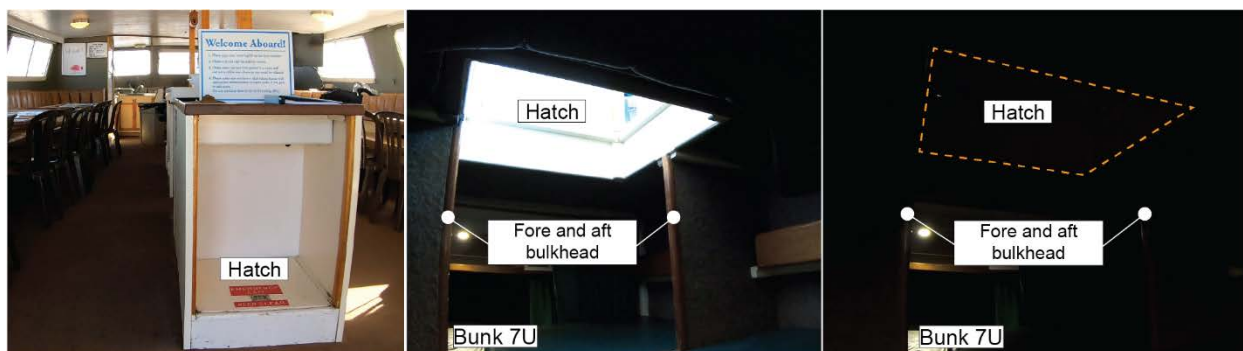
An escape hatch was installed on the centerline at the aft end of the bunk room that led to the aft end of the salon and was original to the vessel. In all available historic documentation and inspection history of the *Conception*, no discrepancies or modifications were found related to the emergency escape hatch. The hatch was accessible from either aisle by climbing a wooden ladder, located in the corner where the aftermost middle and aft athwartship tiers of bunks were, through a privacy curtain (if not opened) onto the top bunk, crawling to the centerline over bedding and personal effects, and pushing the plywood escape hatch out of the way. The escaping passenger

17  
18 **Figure 13: The *Conception* berthing area escape hatch from above in the salon (left) and from the**  
19 **port side, below deck with the hatch open (middle), and with the hatch closed (right). (Source: Ralph**  
20 **A. Clevenger photography and video)**
