# National Transportation Safety Board

## Group Chairman's Factual Report

Fire and Explosions Group

DCA19MM047

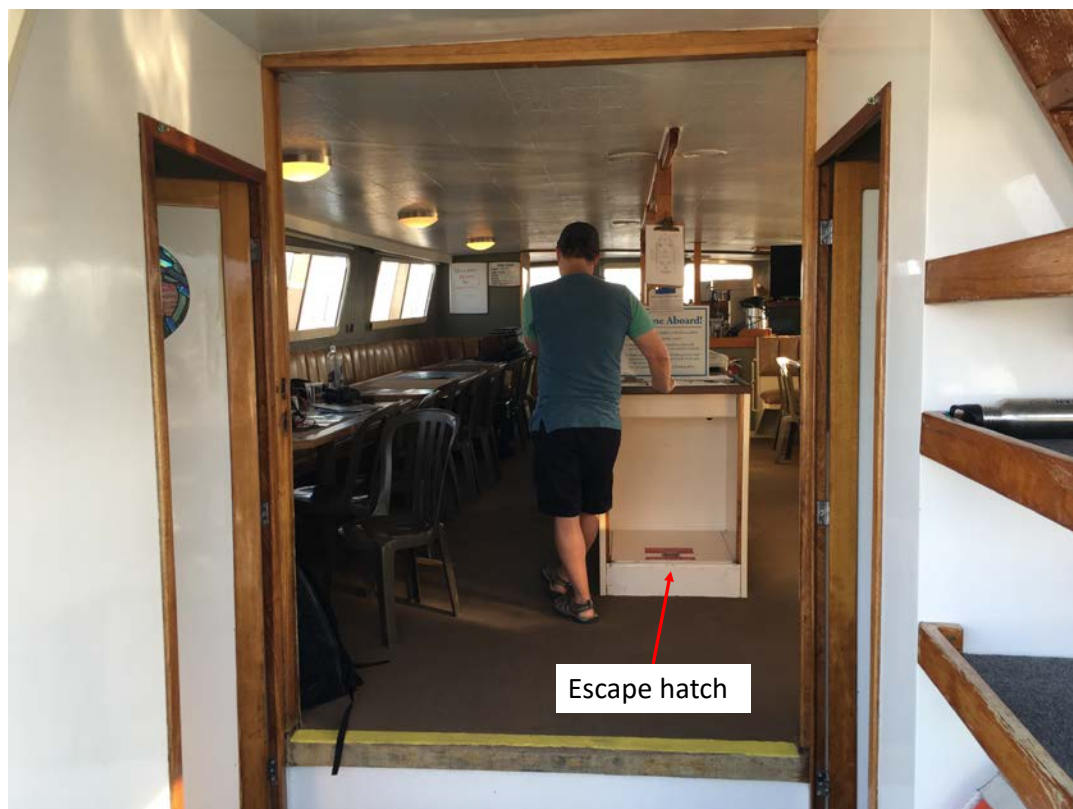
The salon and galley had a main exit at the aft end of the compartment which led to the open part of the aft main deck, there were a set of double doors which were kept open at sea. (figure 8).

Figure 8. Photo looking forward into the main entrance to the salon on the Conception. (Source: G. Boyer)

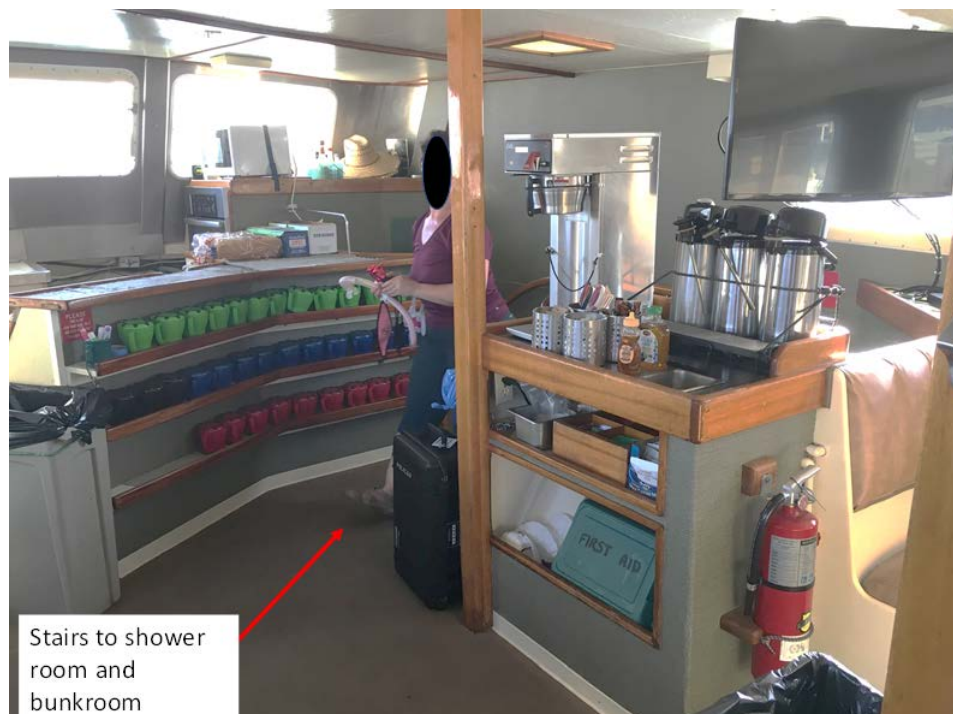
Stairs to shower  
room and  
bunkroom

The lower deck, located within the hull, housed the passenger overnight accommodation space, known as the bunkroom; shower room; engine room; and lazarette. Access to the bunkroom was via a staircase (figure 10) located towards the front of the salon/galley compartment (figure 11). In the same area of the galley, a separate staircase provided access to the washroom, known on board as the shower room. The bunkroom consisted of three levels of bunks along the centerline of the compartment and two levels of bunks (the bunks along the sides were double wide bunks) along two aisleways that joined at the forward end of the bunkroom, where some standing space and a dressing room were located (figure 12). The bunks were constructed of wood (figure 13). The floor and the interior

Figure 11. Bunkroom staircase location at the forward starboard side of the salon. (Source: G. Boyer)

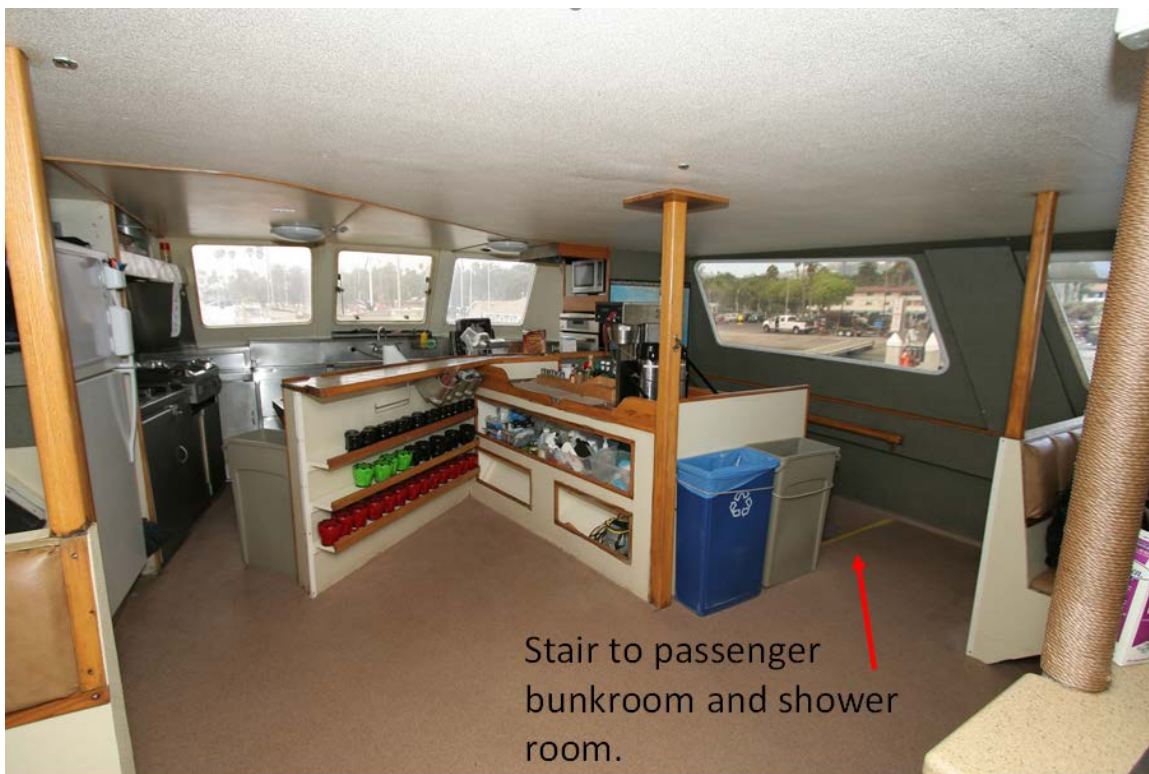
Figure 27. Galley area on the *Vision*. Note, similar to the *Conception*, the center window is the only one with hinges that allow for it to be opened.

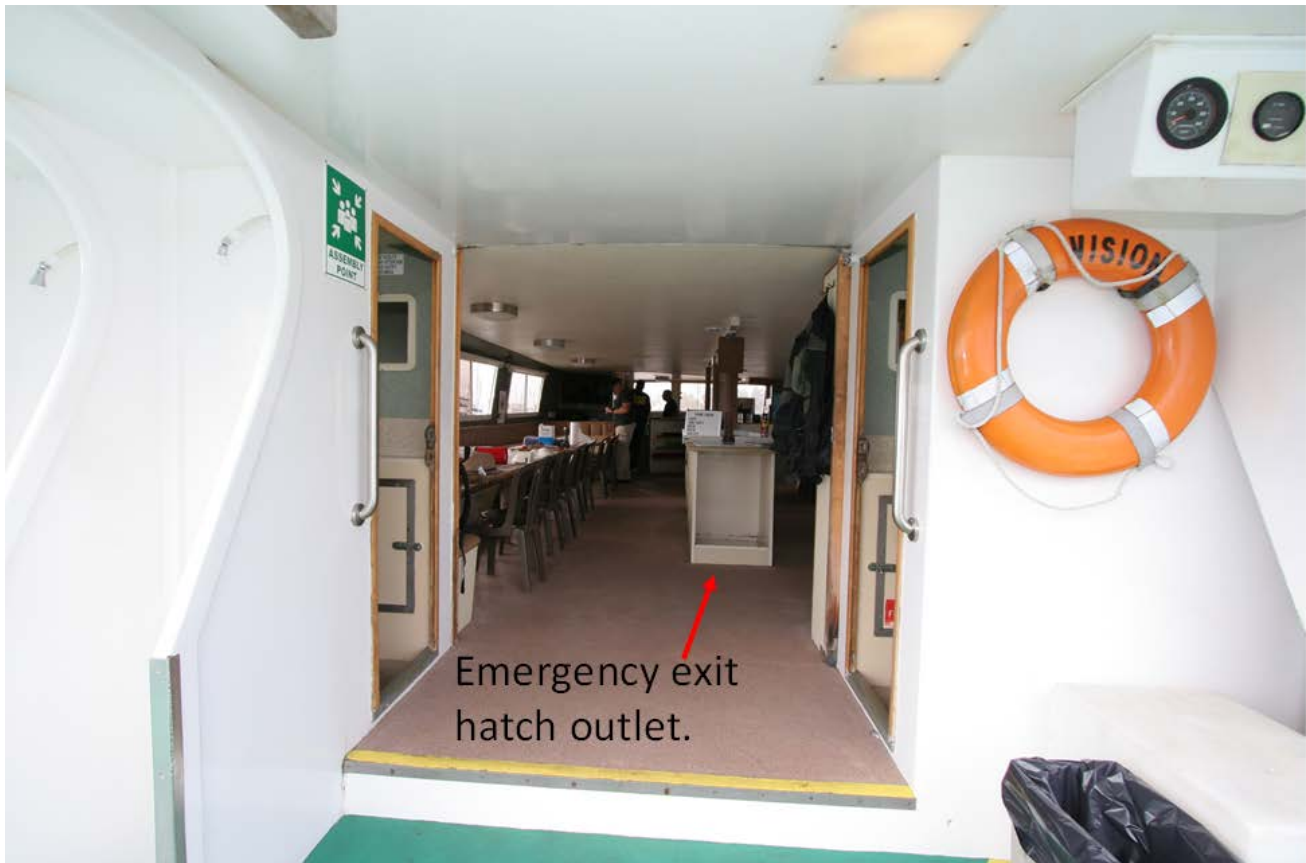
Figure 31. Location of the passenger bunkroom emergency exit hatch outlet in the salon of the *Vision*.
