# National Transportation Safety Board

## Group Chairman's Factual Report

### Survival Factors Group

DCA19MM047

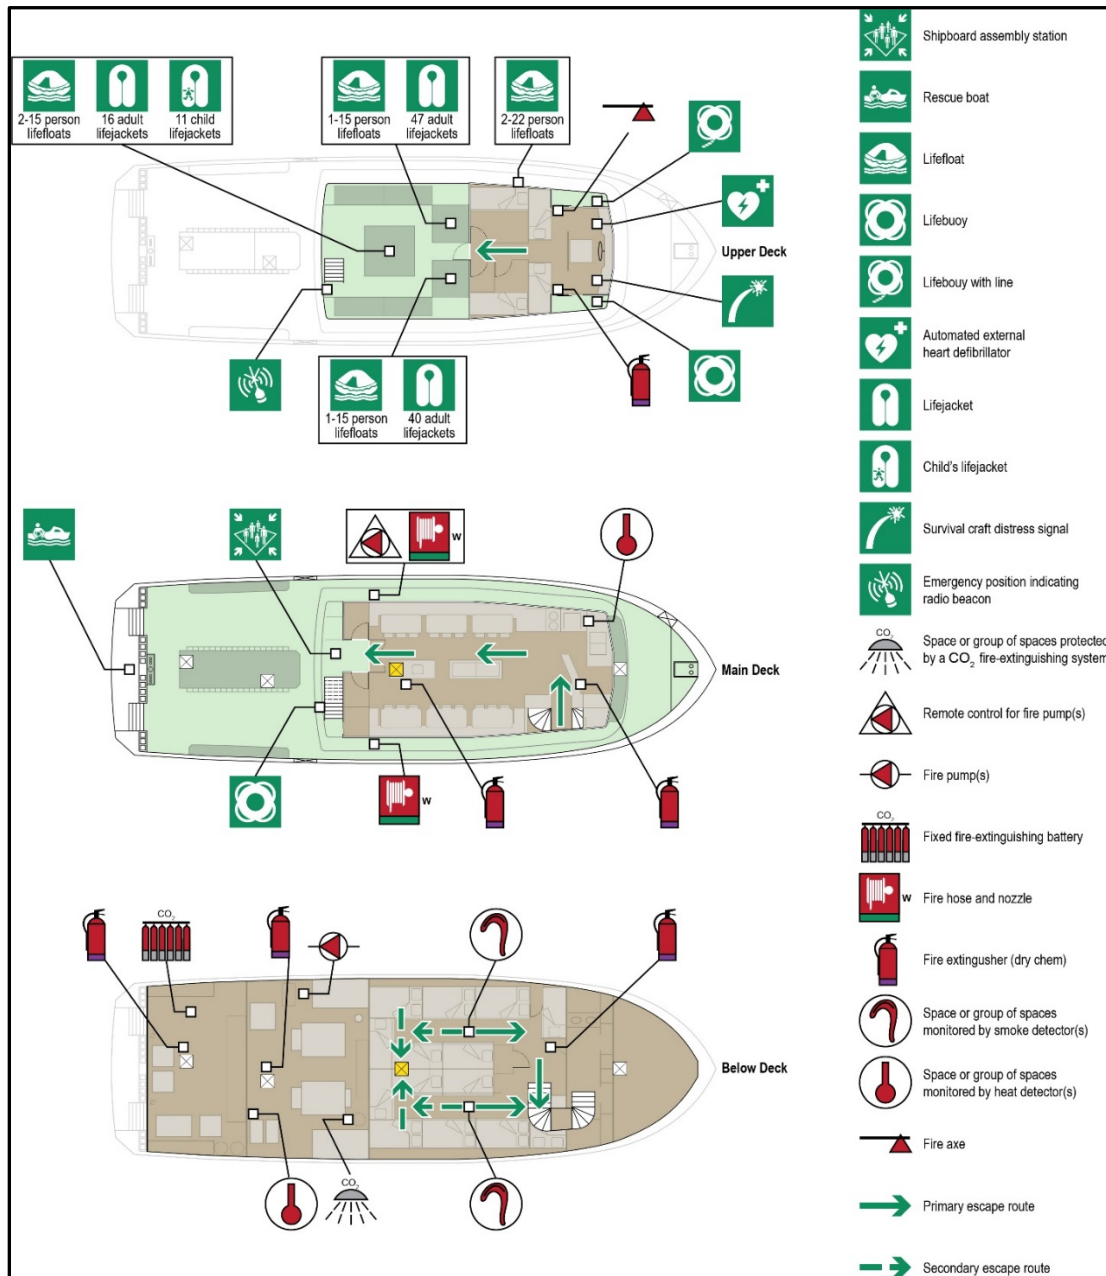
Figure 8: Fire, lifesaving appliance and evacuation plan for the *Conception*.

20       The lifefloats and lifejackets were all stored in plywood boxes on the upper deck, with  
21 plywood covers designed to float off. The crew did not have time to retrieve any lifesaving  
22 equipment before abandoning ship, and all equipment was consumed in the fire. Investigators  
23 recovered only one small piece of a burnt lifefloat.
